Contract #: 04-0120F4Cty: SF/ALA Rte: 80 PM: 13.2/13.9File #: 69.28**WELDING INSPECTION REPORT****Resident Engineer:** Pursell, Gary**Address:** 333 Burma Road**City:** Oakland, CA 94607**Report No:** WIR-003706**Date Inspected:** 23-Aug-2008**Project Name:** SAS Superstructure**OSM Arrival Time:** 1330**Prime Contractor:** American Bridge/Fluor Enterprises, a JV**OSM Departure Time:** 2230**Contractor:** Zhenhua Port Machinery Company, Ltd (ZPMC), Changxing Island **Location:** Shanghai, China**CWI Name:** See below**CWI Present:** Yes No**Inspected CWI report:** Yes No N/A**Rod Oven in Use:** Yes No N/A**Electrode to specification:** Yes No N/A**Weld Procedures Followed:** Yes No N/A**Qualified Welders:** Yes No N/A**Verified Joint Fit-up:** Yes No N/A**Approved Drawings:** Yes No N/A**Approved WPS:** Yes No N/A**Delayed / Cancelled:** Yes No N/A**Bridge No:** 34-0006**Component:** OBG Fabrication**Summary of Items Observed:**

WELDING INSPECTION REPORT

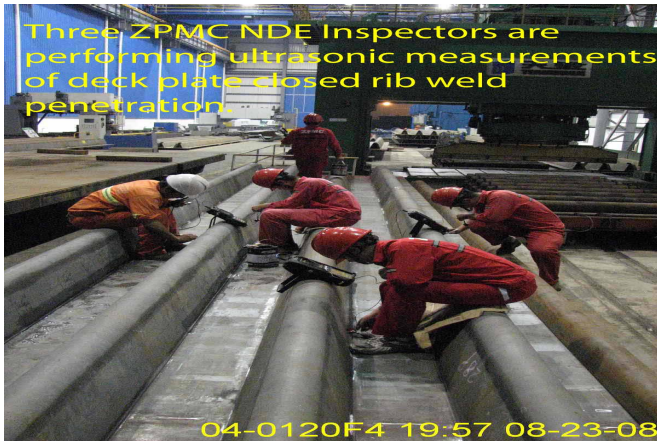
DP363-001 and DP417-001 are in gantry #2. QC does not appear to have completed MT inspections of the tack welds.
